# Pre-Renovation Regulated Building Materials Inspection

156 Fall Street  
Seneca Falls, New York 13148

LaBella Project No. 2192346

August 2019

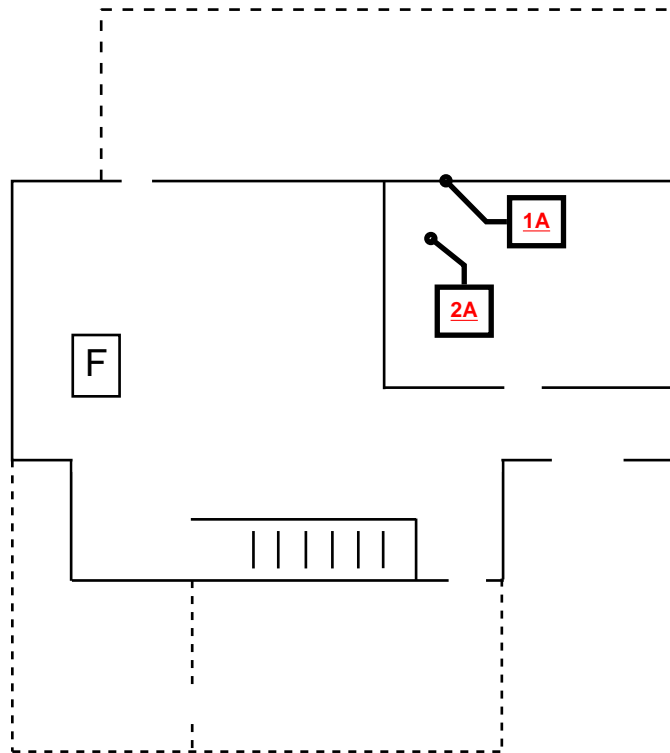
Project Number: 2192346  
156 Fall Street, Seneca Falls  
Basement Bulk Samples

Confirmed ACM **1A**

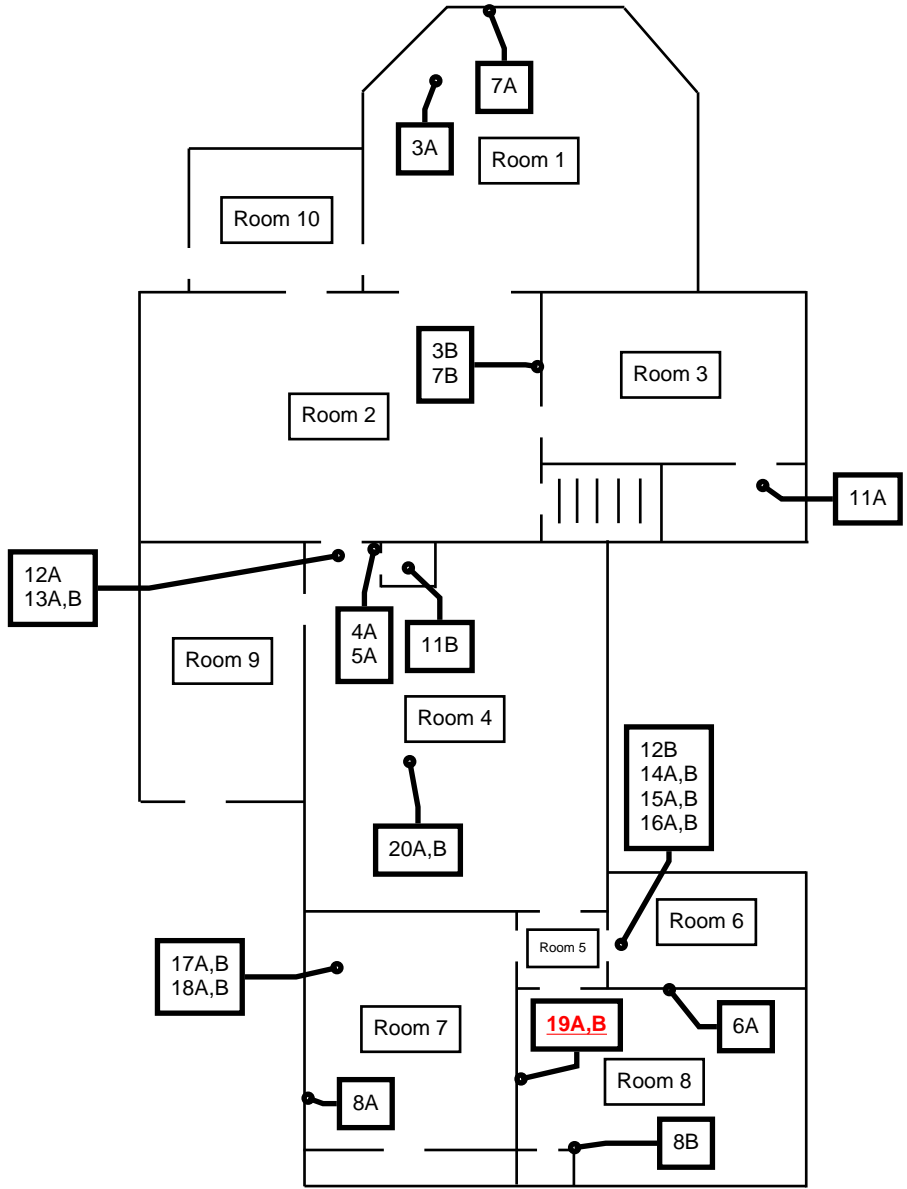
Project Number: 2192346  
156 Fall Street, Seneca Falls  
1st Floor Bulk Samples

Confirmed ACM **19A,B**

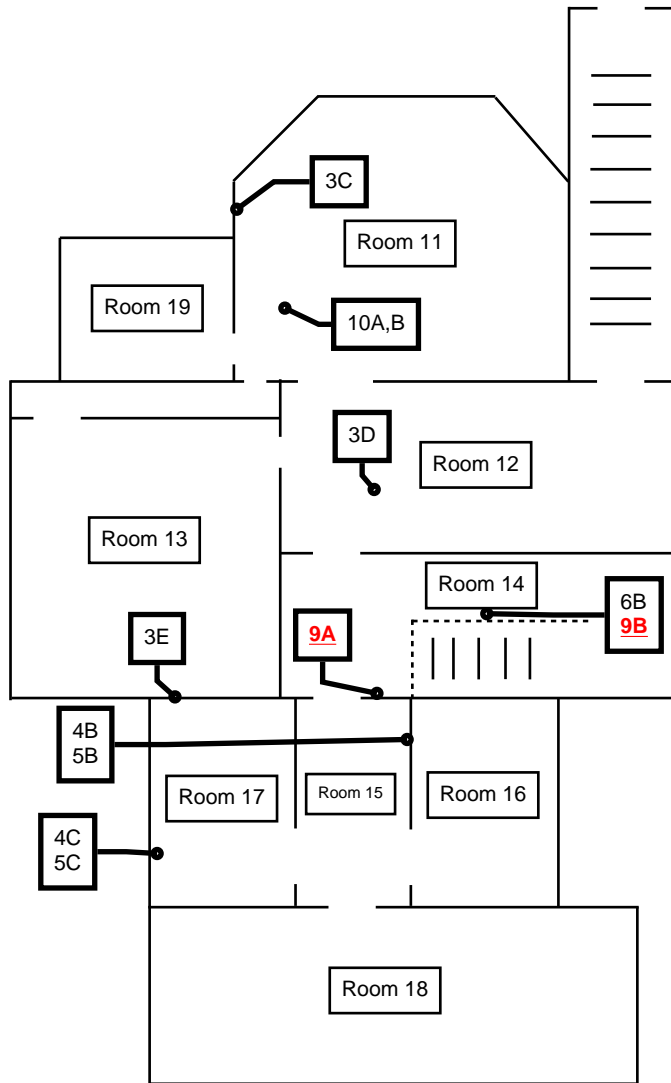
Project Number: 2192346  
156 Fall Street, Seneca Falls  
2nd Floor Bulk Samples

Confirmed ACM **9A** **9B**

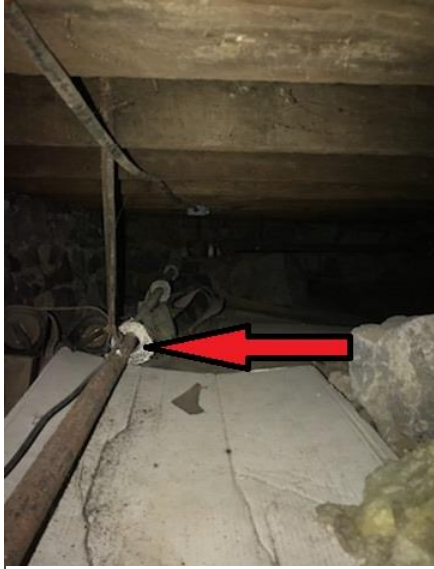
Photo 1

The gray asbestos-containing pipe insulation and associated asbestos-containing gray mud fittings within the basement and crawlspaces were observed to be in fair condition. No loose asbestos-containing debris was observed on the ground at the time of the inspection. However, most of the pipes in the basement are bare, with several fittings noted with residual insulation still present. The potential exists for the asbestos-containing insulation and/or asbestos-containing fittings to be damaged in the near future due to the building having no power or water.

Gray asbestos-containing pipe insulation located on the pipes in the crawlspace of the basement

If damaged asbestos-containing insulation and/or asbestos-containing mud fittings are observed at any point, the presence of this damaged material represents an "Incidental Asbestos Disturbance" as defined by New York State Asbestos Regulations, (i.e. Industrial Code Rule 56). According to these regulations, personnel access to the areas affected shall be restricted until such time as the material is cleaned up by a licensed asbestos abatement contractor. If this situation occurs, the clean-up of this material shall take place as soon as possible.

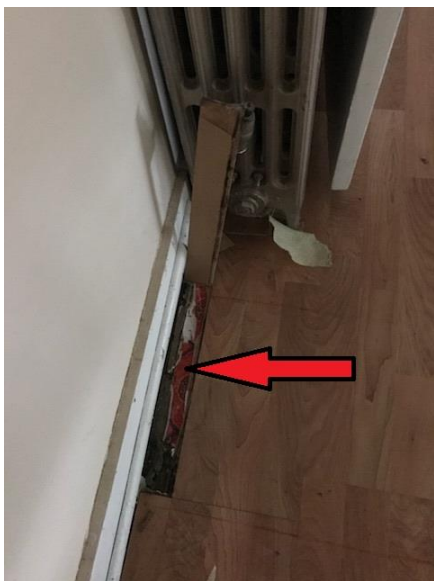
Photo 2

Red/gray asbestos-containing sheet vinyl located on the 2<sup>nd</sup> layer of flooring in room 8

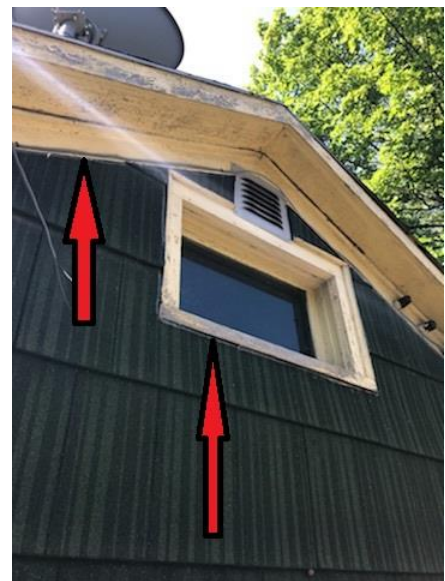
Photo 4

Black asbestos-containing roofing cement is located along the house (on shingles) where lower sections of roof connect to the house. The roofing cement was also observed around the chimney.

Black asbestos-containing caulk located along the edges of the shingles on the exterior of the house
