Lead-Based Paint Risk Assessment

156 Fall Street
Seneca Falls, New York 13148

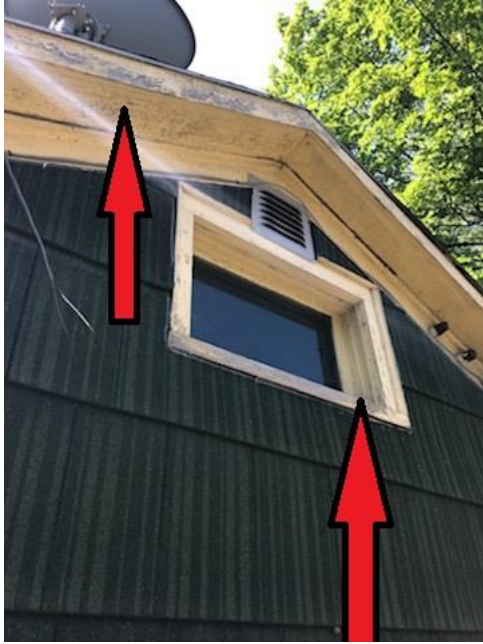
Yellow painted exterior wooden window components and trim. All of the yellow components are lead-based. The continued operation of the window makes this a friction hazard.

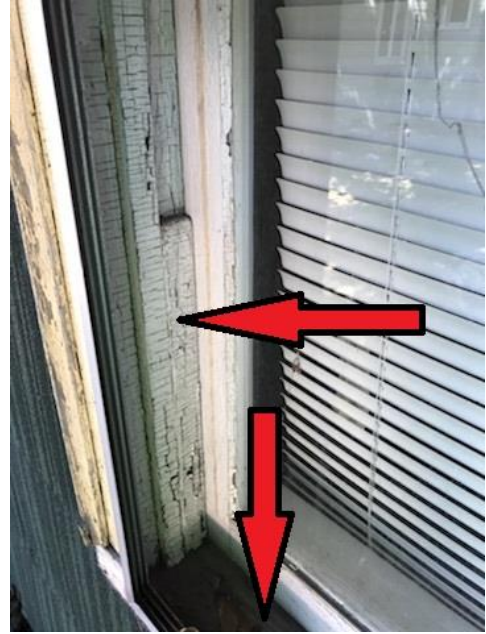
White painted wooden window jamb and gray well. This deteriorated paint, combined with the operable window, represents impact and friction hazards.

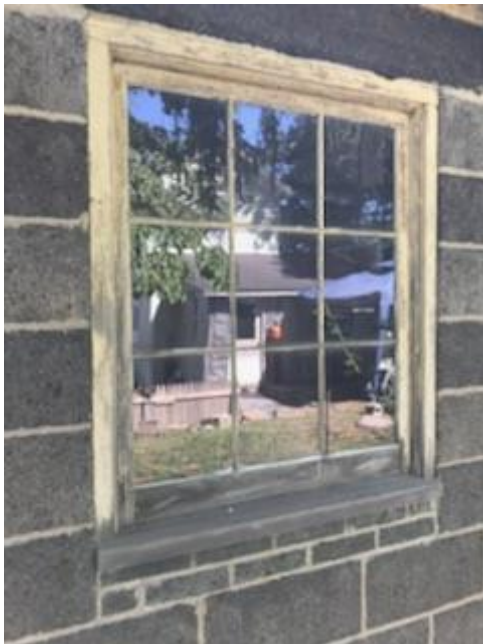
Yellow painted wooden window components on the garage. The paint used on these original windows are lead-based.

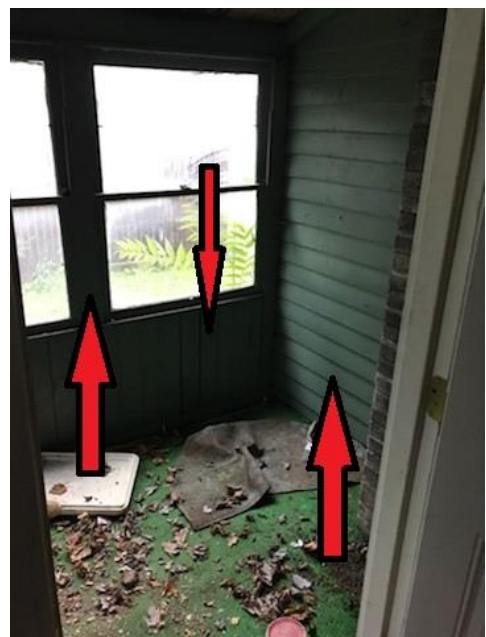
Green painted wooden porch wall and window components. The damage sustained to the components is evidence of weather exposure.
