# Pre-Renovation Regulated Building Materials Inspection

156 Fall Street  
Seneca Falls, New York 13148

LaBella Project No. 2192346

August 2019

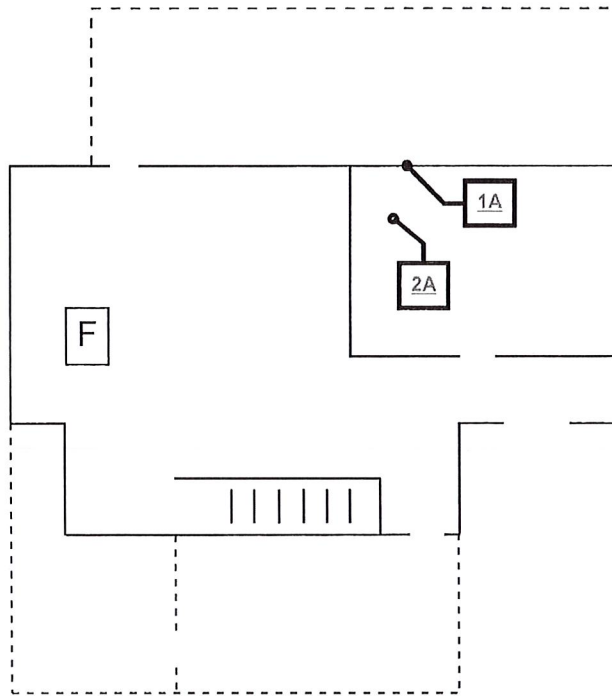
Project Number: 2192346  
156 Fall Street, Seneca Falls  
Basement Bulk Samples

Confirmed ACM **Bold and Underlined**

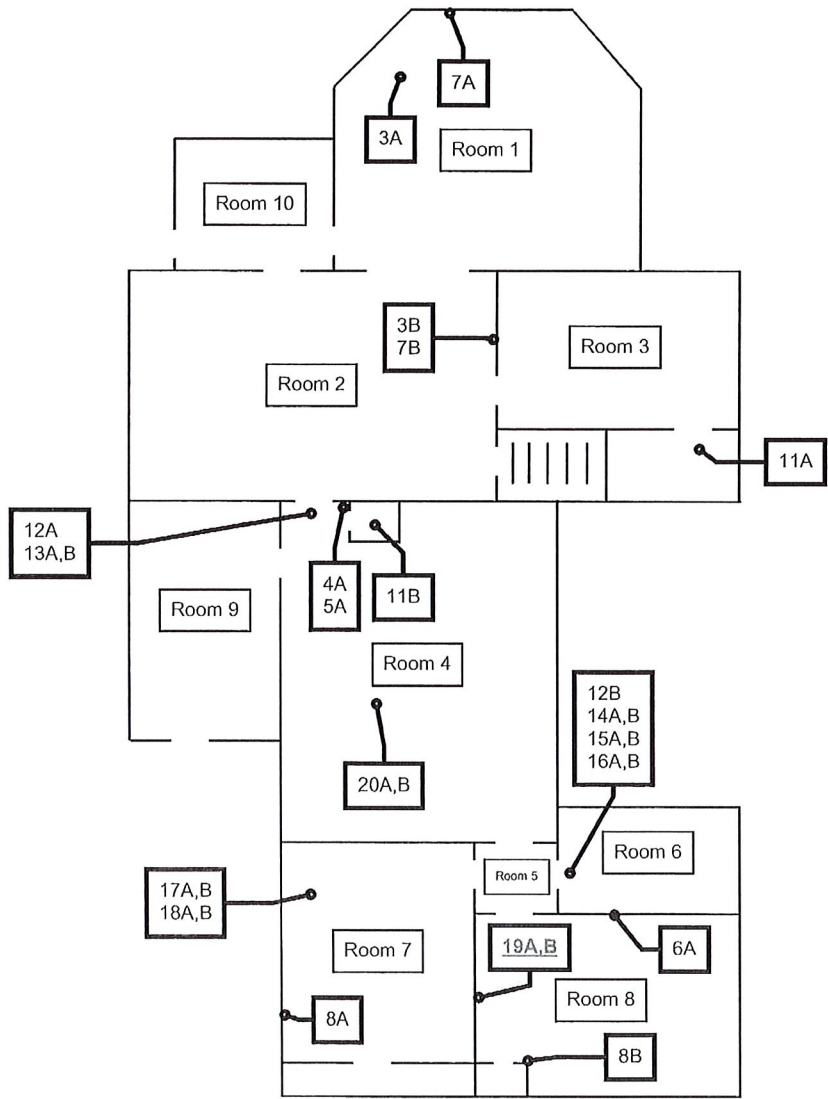
Project Number: 2192346  
156 Fall Street, Seneca Falls  
1st Floor Bulk Samples

Confirmed ACM **12A, 13A, B, 17A, B, 18A, B, 19A, B, 20A, B**

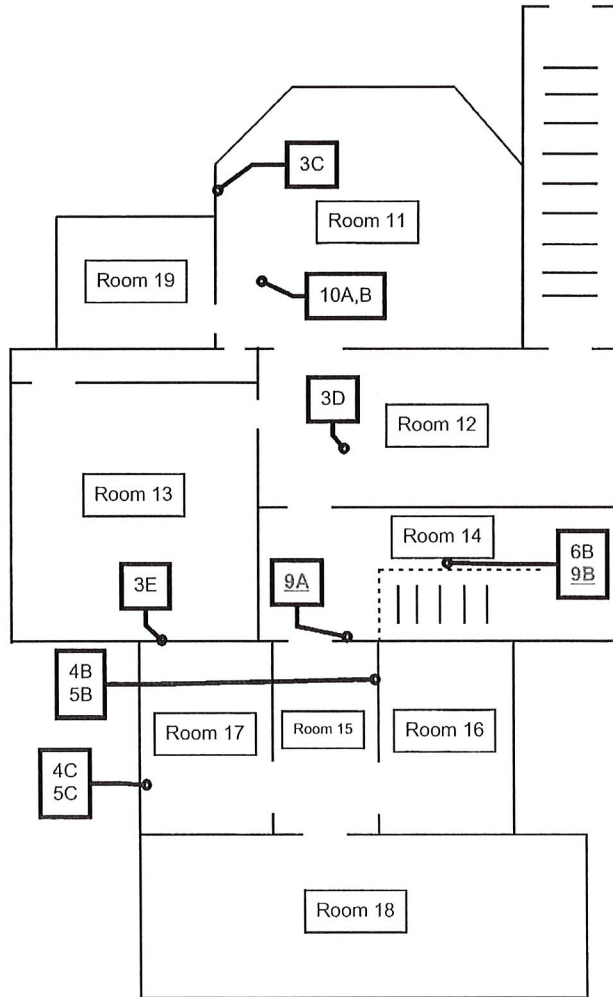
2nd Floor Bulk Samples

Confirmed ACM **Bold and Underlined**

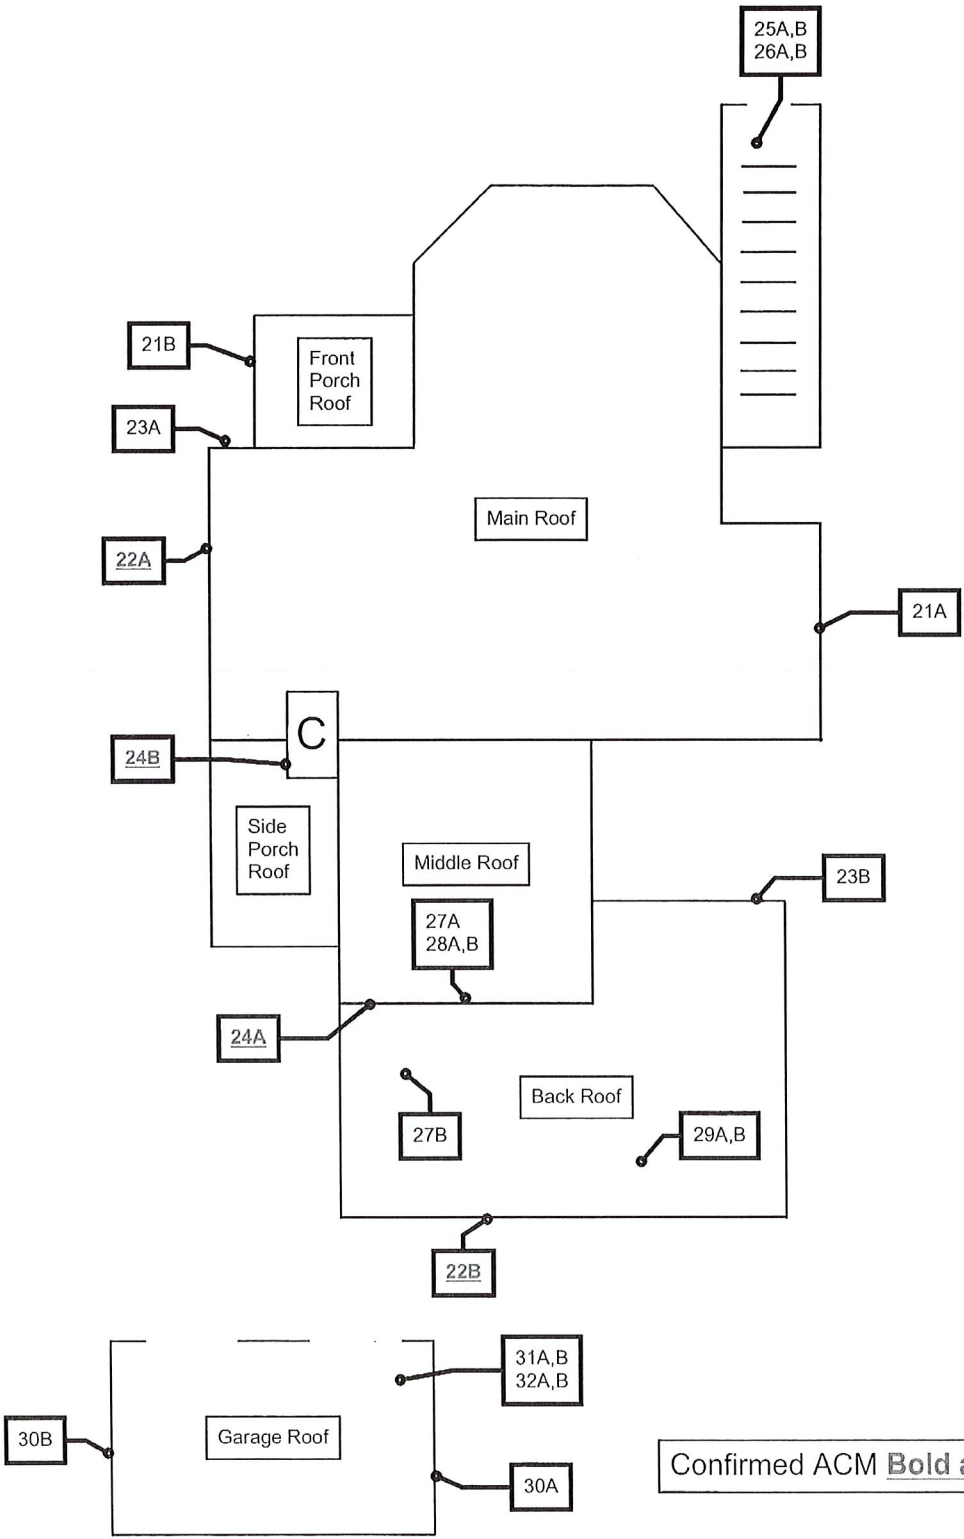
Project Number: 2192346  
156 Fall Street, Seneca Falls  
Exterior Bulk Samples

Confirmed ACM **21A**

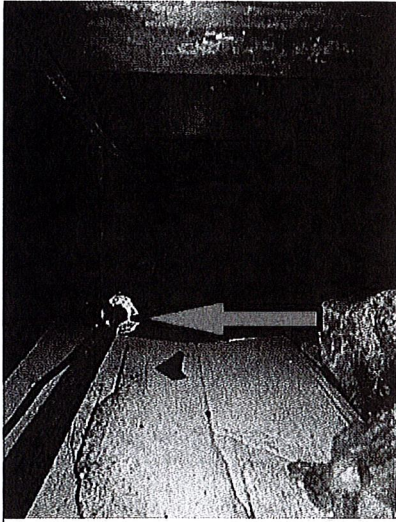
Photo 1

The gray asbestos-containing pipe insulation and associated asbestos-containing gray mud fittings within the basement and crawlspaces were observed to be in fair condition. No loose asbestos-containing debris was observed on the ground at the time of the inspection. However, most of the pipes in the basement are bare, with several fittings noted with residual insulation still present. The potential exists for the asbestos-containing insulation and/or asbestos-containing fittings to be damaged in the near future due to the building having no power or water.

Gray asbestos-containing pipe insulation located on the pipes in the crawlspace of the basement

If damaged asbestos-containing insulation and/or asbestos-containing mud fittings are observed at any point, the presence of this damaged material represents an "Incidental Asbestos Disturbance" as defined by New York State Asbestos Regulations, (i.e. Industrial Code Rule 56). According to these regulations, personnel access to the areas affected shall be restricted until such time as the material is cleaned up by a licensed asbestos abatement contractor. If this situation occurs, the clean-up of this material shall take place as soon as possible.

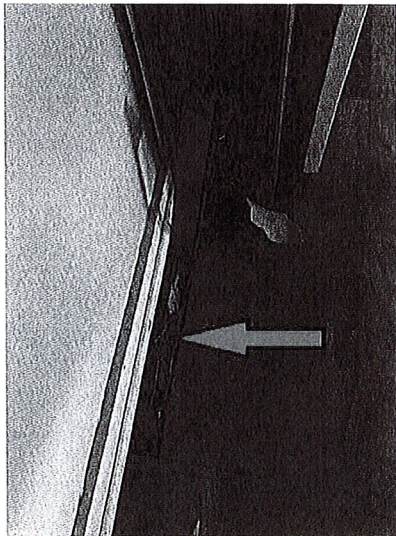
Photo 3

Red/gray asbestos-containing sheet vinyl located on the 2<sup>nd</sup> layer of flooring in room 8

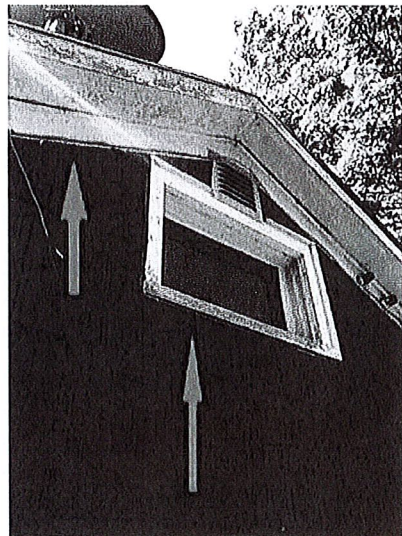
Photo 4

Black asbestos-containing caulk located along the edges of the shingles on the exterior of the house
